# LONG-TERM EFFECTS OF HAIL IMPACT ON ASPHALT SHINGLES—AN INTERIM REPORT

**SCOTT J. MORRISON**  
Haag Engineering Co.  
Carrollton, Texas, U.S.A.

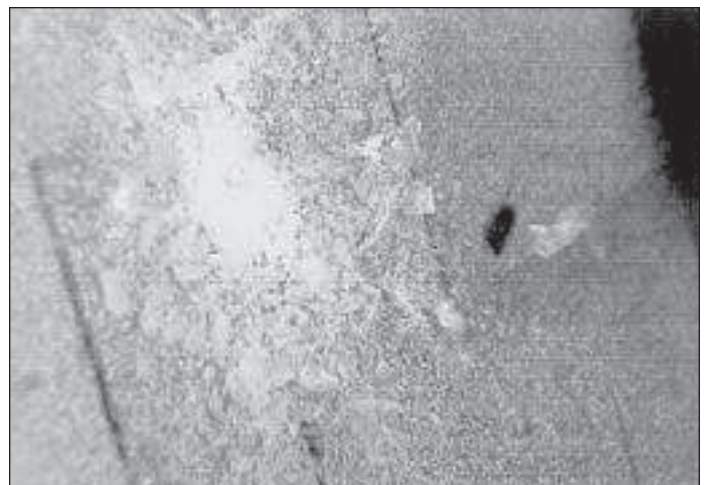
*Photo 2. Shingle impacted by a simulated hailstone.*

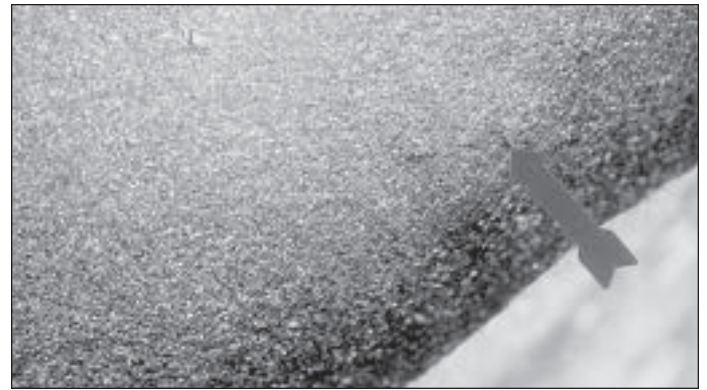
Photo 5. Close-up on bottom side of D-7 of half-panel designation CO-TS-D-7 at impact site. Note single-line fracture pattern weathered 4 years 4 months.

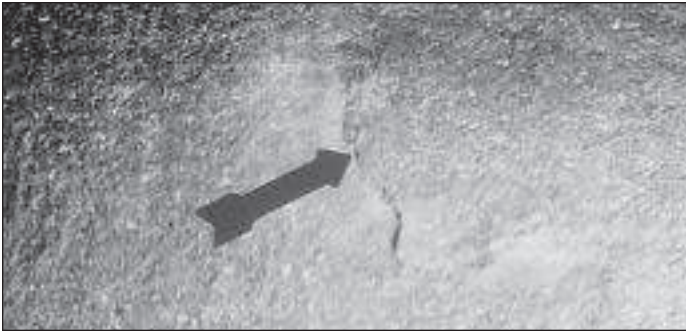
**Photo 6.** Close-up on bottom side of Tab D-4 of half-panel designation CO-FS-D-7 at impact site. Note curved-line fracture pattern weathered 4 years 4 months.

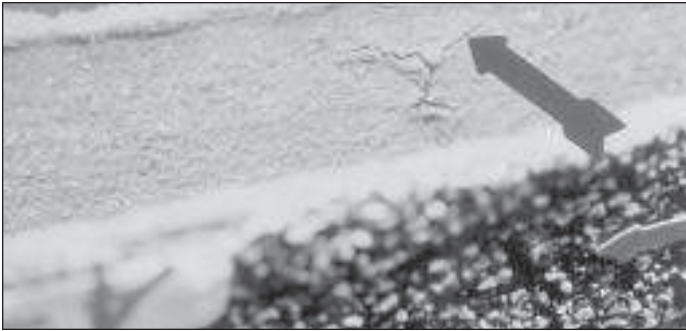
**Photo 7.** Close-up on bottom side of Tab A-5 of half-panel designation CO-WFB-D-7 at impact site. Note multi-line fractures radiating from common point.

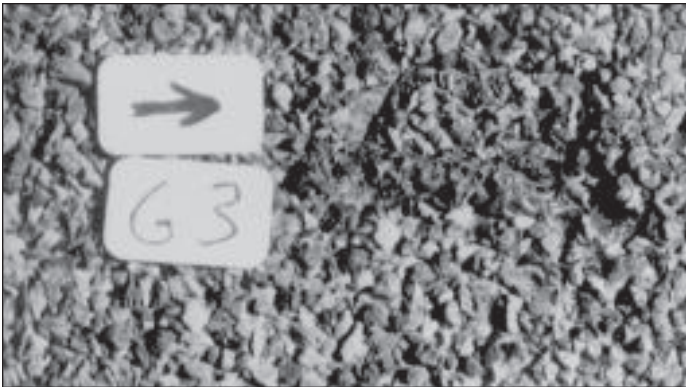
**Photo 8.** Close-up of Tab G-3, half-panel designation CO-FS-D-0 at 10 years 6 months weathering exposure. Note impact-caused fracture.

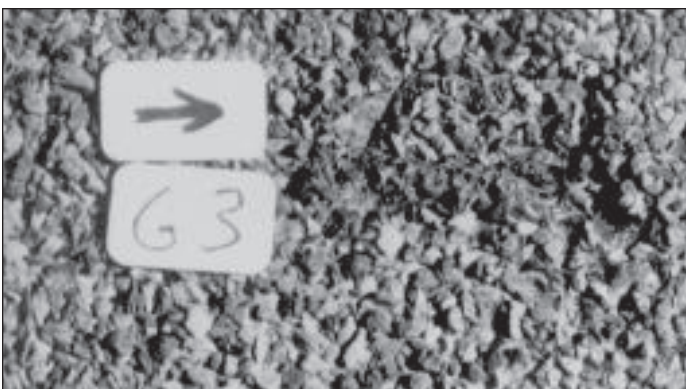
**Photo 9.** Close-up of Tab G-3, half-panel designation CO-FS-D-0 at 14 years 11 months weathering exposure. Note impact-caused fracture.

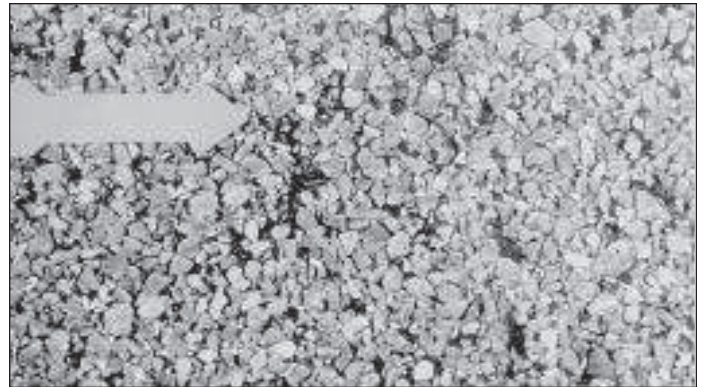
**Photo 10.** Close-up of D-2 of half-panel designation CO-TS-D-0 at 14 years 11 months weathering exposure. Note that granules were detected below the asphalt in vicinity of arrow.

- Some impacts made with freezer ice on laminated shingles dislodged granules from exposures without exposing asphalt. Granules subsequently were shed at impact locations over time with natural weathering. Careful examination at these locations revealed a continuous bed of granules immersed in the asphalt. There was no reduction in the expected service life of the shingles as granules on the shingles continued to protect the underlying asphalt and reinforcement. The condition was not functional damage but merely a cosmetic condition.

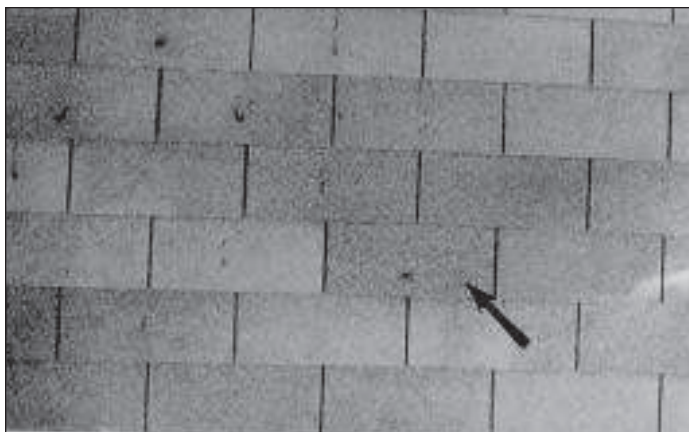
**Photo A2.** View of test panel at Year 0 after impacting. Note fracture in Tab G-3.

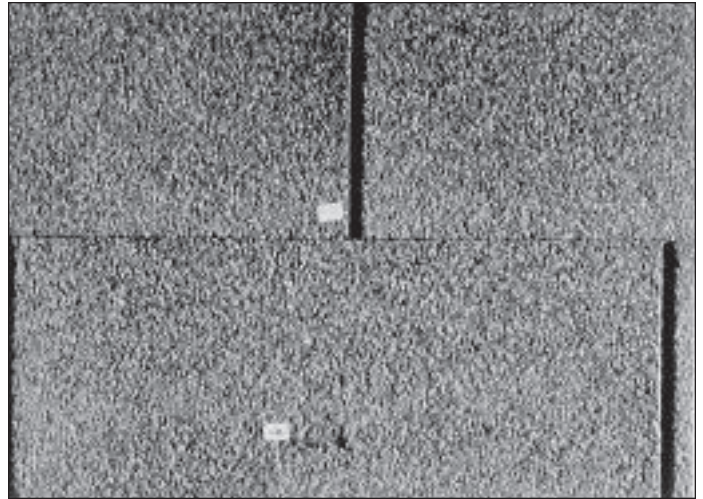
**Photo A3.** Close-up at Tab G-3 at 10 years 6 months weathering exposure. Note fracture.

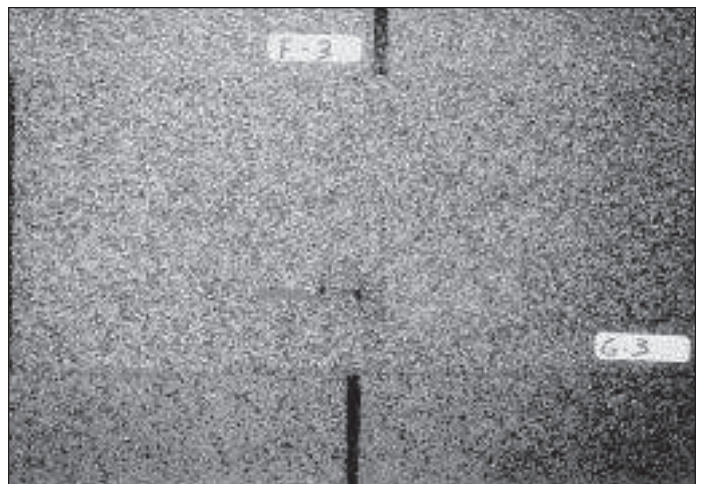
**Photo A5.** Close-up of Tab G-3 at 14 years 11 months weathering exposure. Note impact-caused fracture.

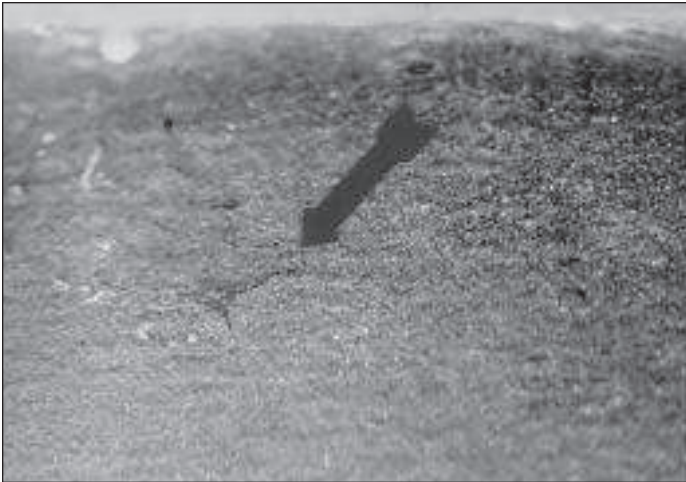
**Photo C6.** Close-up on bottom side of Tab C-5 at area depicted in Photo C5. Note fracture.

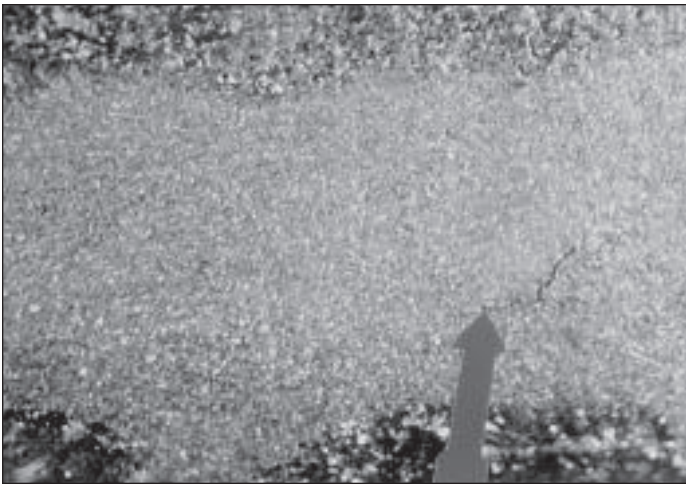
*Photo D6. Close-up on bottom side of D-10 at location depicted in Photo D5. Note fracture.*
