# EVALUATION OF HAIL-STRIKE DAMAGE TO ASPHALT SHINGLES BASED ON

HAILSTONE SIZE,  
ROOF PITCH,  
DIRECTION OF INCOMING STORM,  
AND  
FACING ROOF ELEVATION

By **STEPHEN PETTY, PE, CIH, MARK PETTY, AND TIM KASBERG**

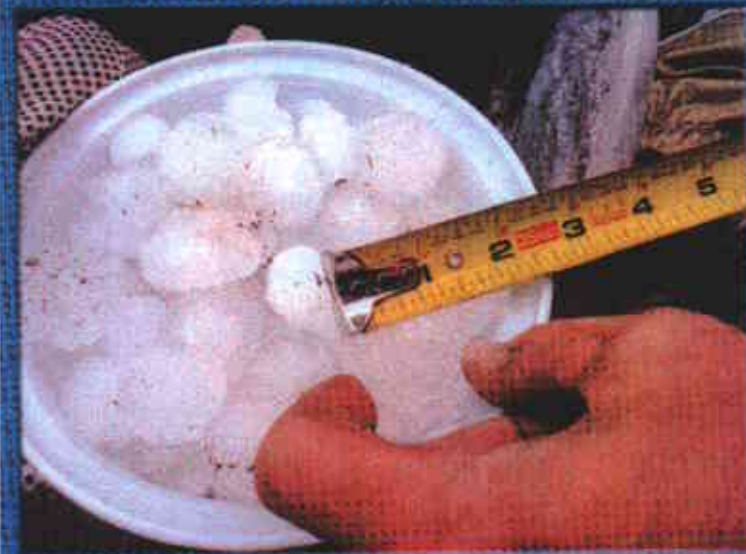
Hailstones from October 4, 2006, hailstorm in Gahanna, Ohio.

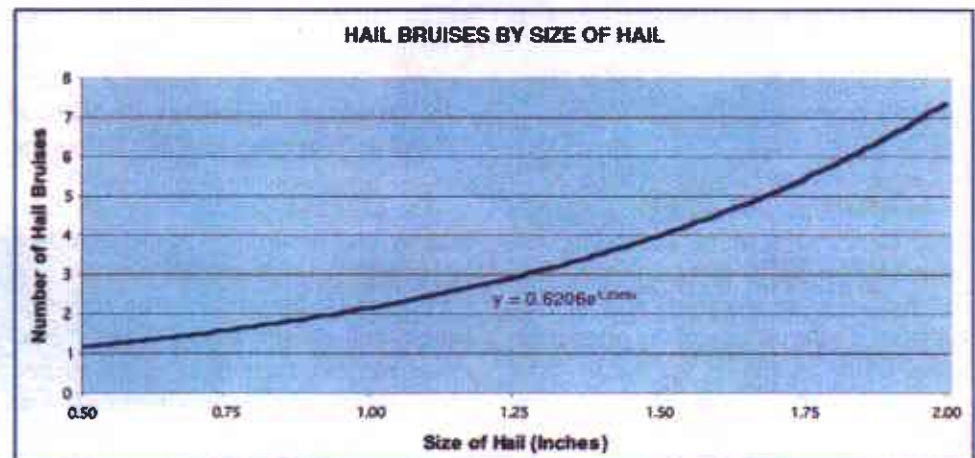
Figure 2 - Hail bruises by size of hail.

Remaining data sets were broken down into hail-size subgroups of 1/8 in to 3/4 in, 7/8 in to 1 in, 1-1/8 in to 1 1/2 in, 1-5/8 in to 2 in, and greater than 2 in. Similarly, the bruise counts per 100 sq ft were collected from measured field values. Using this information, a scatter plot graph was created by placing the mean hail size for each subgroup on the x-axis and the mean number of bruise counts on the y-axis. Using this data, the number of hail bruises was found to increase exponentially as the size of the hail increases (Figure 2).

The number of hail-strike bruises increases at an exponential rate as the size of hail increases. Our data show that hail must reach approximately 1½ inches in order to leave a bruise count of five bruises per 100 sq ft of asphalt shingles. The level of bruises per 100 sq ft at which insurance companies consider a roof damaged sufficiently to be replaced varies but appears to range from about six to ten hail-strike bruises per 100 sq ft of roofing. A line of best fit was generated from our data points to include this information. This line was set to zero hail-strike bruises when hail was not present (by making the hail size equal to 0.0 inches in diameter) and yielded the equation  $y = 0.6205^{e^{1.2269x}} - 0.6205$ . Using this equation, it was calculated that the estimated diameters needed to achieve six and ten hail bruises per 100 sq ft of asphalt shingle roofing were 1.91 inches in diameter and 2.30 inches in diameter, respectively.

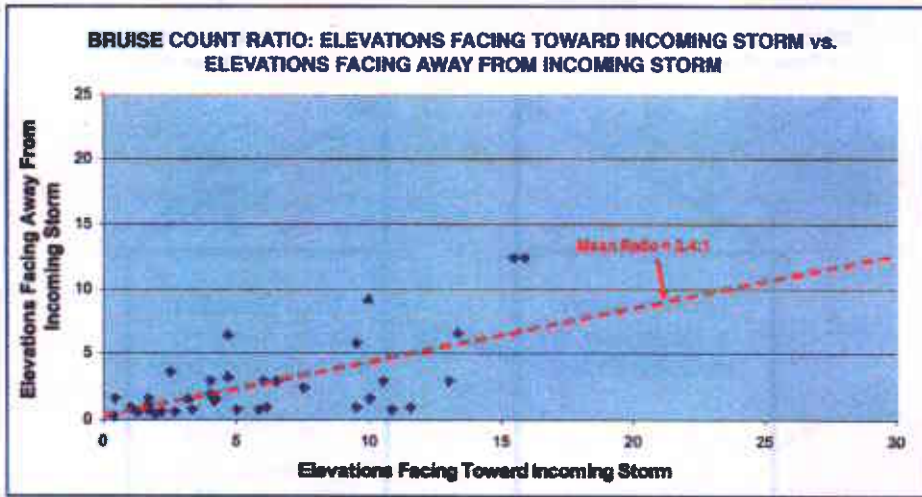
the incoming storm was then compared to the number of bruises on the roof elevations facing away from the storm and turned into a ratio. Using results from 51 site inspections, the study found this ratio to be 2.4:1

(see Figure 5 and Table 2). Thus, a roof facing the incoming storm had bruise counts nearly two and a half times that of the roof elevation facing away from the incoming storm.

Figure 5 – Bruise count comparisons between roof elevations facing an incoming storm and roof elevations facing away from an incoming storm.

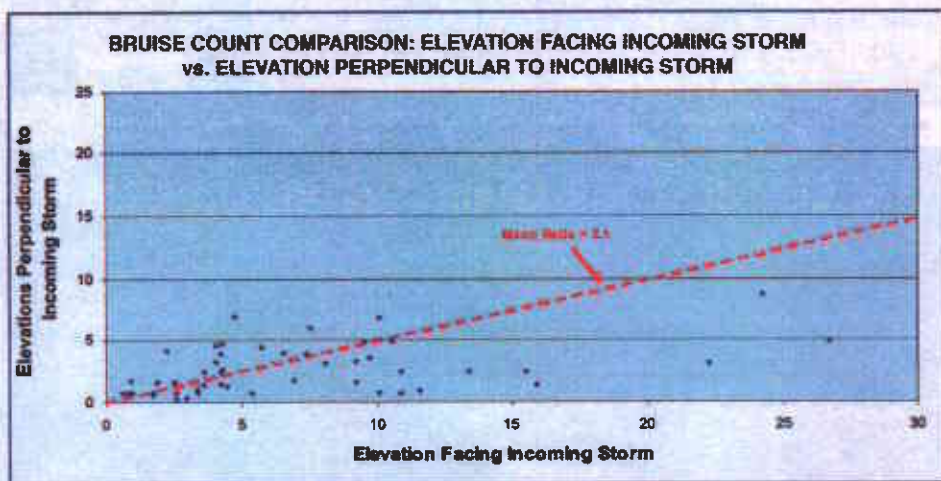
the number of bruises on the roof elevations perpendicular to the incoming storm and turned into a ratio. Using data from 100 site inspections, the study found this ratio to be 2.1:1 (see Figure 7 and Table 3). Thus, a roof facing the incoming storm had bruise counts just over two times that for roof elevations perpendicular to the incoming storm.

Figure 7 – Bruise count comparisons between roof elevations facing an incoming storm and roof elevations perpendicular to an incoming storm.
